**Flood Control Project Maintenance
Levee Inspections**

Maintenance Issue Types Only, Levee Inspection Report By Mile - Spring 2018

Tehama County Flood Control and Water Conservation District

Waterway	Bank	Unit Miles	Inspection Start/End	Inspector
Unit No. 01 Deer Creek	Left	4.22	04/04/2018 04/04/2018	Bob Duffey

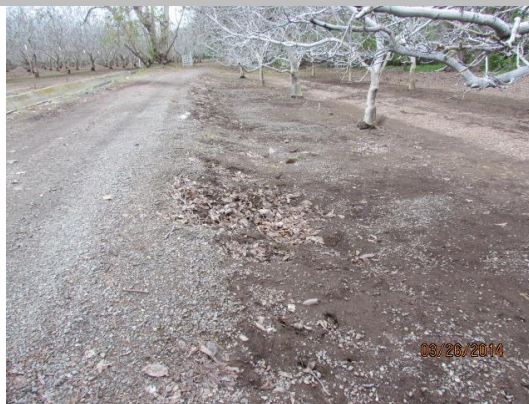
Photo 1 of 1 : SP_2018_NA0019_78_276_20180305_00024.jpg

LM Start	0.45	Rating **	M	Issue No.	276
LM End	0.45	Issue Type +	Ma	Location *	WS
Category	Earthen Levee			GPS Latitude/Longitude	
				Start	End
Item	Slope Stability			39.972377 °	39.972377 °
				-121.988559 °	-121.988559 °
DWR ID	DWR_NA0019_01_s_2014_276				
Comment Code					
S1 : Repair slope instability.					
Inspector Comment

View of the erosion along the waterside slope.

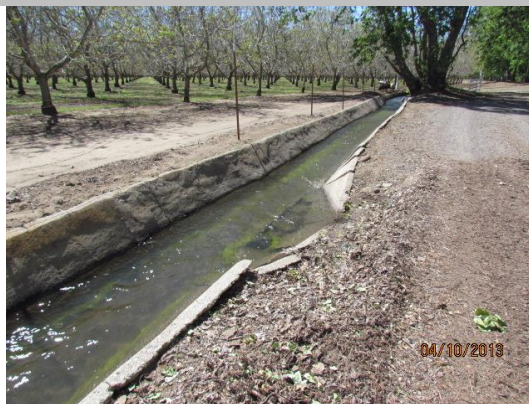
Photo 1 of 1 : SP_2018_NA0019_78_19_20180305_00007.jpg

LM Start	0.46	Rating **	M	Issue No.	19
LM End	0.46	Issue Type +	Ma	Location *	LS
Category	Earthen Levee			GPS Latitude/Longitude	
				Start	End
Item	Erosion / Bank Caving			39.972339 °	39.972339 °
				-121.988763 °	-121.988763 °
DWR ID	DWR_NA0019_01_s_2013_19				
Comment Code					
E1 : Note and monitor erosion site.					
Inspector Comment

View of the erosion along the landside slope.

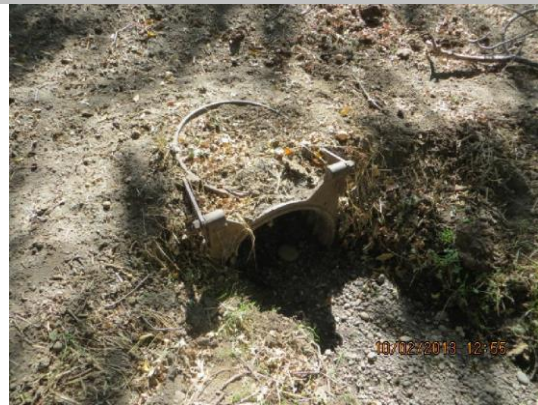
Photo 1 of 3 : UCIP_SP_2018_51437_36922.jpg

Comment Code					
Inspector Comment					
FS_ID:51437					
DS_ID:20770					
EP_NO: N/A					
Repair Type: Non-Urgent					
Crossing Status: Found					
UCIP Comments: 12/05/2016 Sediment buildup inside pipe (see photo) and sediment buildup on WS blocking flap gate. Crossing has been downgraded from Urgent to Non-Urgent crossing was closed on both WS and LS. (O. Magana - DWR UCIP)10/02/2013 Flapgate blocked by soil buildup. (W. Wylie - DWR UCIP)					
FIELD_STRUCT_DESC: 24-inch steel drainage pipe through the levee, 1.5 feet below the crown. Flap gate on the waterside (WS) toe.					
[Additional Reference(s): DWR Levee Log, 1992. USACE Sacramento O&M Manual Unit 509, March 1957, As-built drawings available 50-4-2394 (Station 185+40)].					
FS Date: 12/5/2016

Flapgate on WS toe.

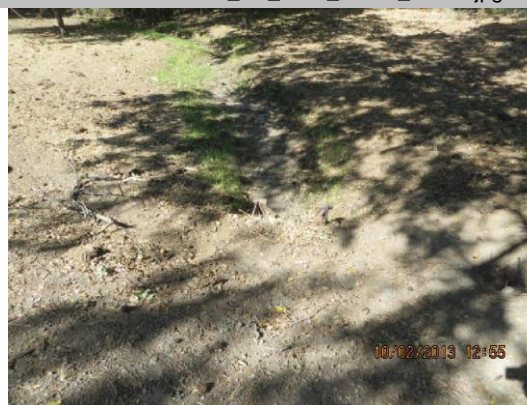
Photo 3 of 3 : UCIP_SP_2018_51437_36920.jpg

FS_ID:51437
DS_ID:20770
EP_NO: N/A
Repair Type: Non-Urgent
Crossing Status: Found
UCIP Comments: 12/05/2016 Sediment buildup inside pipe (see photo) and sediment buildup on WS blocking flap gate. Crossing has been downgraded from Urgent to Non-Urgent crossing was closed on both WS and LS. (O. Magana - DWR UCIP) 10/02/2013 Flapgate blocked by soil buildup. (W. Wylie - DWR UCIP)
FIELD_STRUCT_DESC: 24-inch steel drainage pipe through the levee, 1.5 feet below the crown. Flap gate on the waterside (WS) toe.
[Additional Reference(s): DWR Levee Log, 1992. USACE Sacramento O&M Manual Unit 509, March 1957, As-built drawings available 50-4-2394 (Station 185+40)].
FS Date: 12/5/2016

Outlet on WS toe.

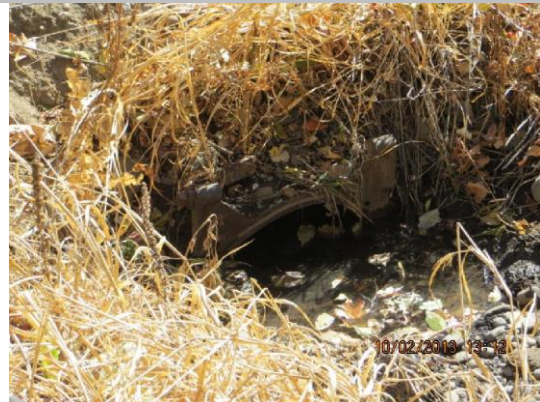
Photo 1 of 3 : UCIP_SP_2018_51438_36925.jpg

Comment Code					
Inspector Comment					
FS_ID:51438 DS_ID:20769 EP_NO: N/A Repair Type: Urgent Crossing Status: Found UCIP Comments: 12/05/2016 same as last inspection. Crossing remains "Urgent" WS opened during flood season due to damaged flap gate. (O. Magana - DWR UCIP)10/02/2013 Flapgate missing or burried on WS toe. Pipe partially blocked by soil on WS toe. (W. Wylie - DWR UCIP) FIELD_STRUCT_DESC: 24-inch corrugated metal drainage pipe through the levee, 7 feet below the crown. Flap gate located on the waterside (WS) end. A 5-foot by 5-foot concrete control structure located on the landside (LS) toe. [Additional Reference(s): DWR Levee Log, 1992. USACE Sacramento O&M Manual Unit 509, March 1957, As-built drawing no. 50-4-2394 (Station 176+10)]. FS Date: 12/5/2016

Pipe on WS toe with flapgate hinges.

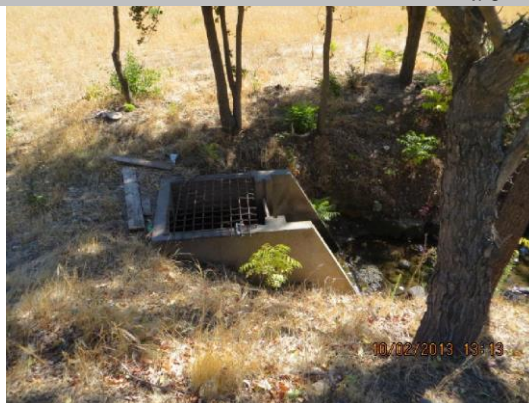
Photo 3 of 3 : UCIP_SP_2018_51438_36923.jpg

FS_ID:51438
DS_ID:20769
EP_NO: N/A
Repair Type: Urgent
Crossing Status: Found
UCIP Comments: 12/05/2016 same as last inspection. Crossing remains "Urgent" WS opened during flood season due to damaged flap gate. (O. Magana - DWR UCIP)10/02/2013 Flapgate missing or buried on WS toe. Pipe partially blocked by soil on WS toe. (W. Wylie - DWR UCIP)
FIELD_STRUCT_DESC: 24-inch corrugated metal drainage pipe through the levee, 7 feet below the crown. Flap gate located on the waterside (WS) end. A 5-foot by 5-foot concrete control structure located on the landside (LS) toe. [Additional Reference(s): DWR Levee Log, 1992. USACE Sacramento O&M Manual Unit 509, March 1957, As-built drawing no. 50-4-2394 (Station 176+10)].
FS Date: 12/5/2016

Concrete control structure on LS toe.

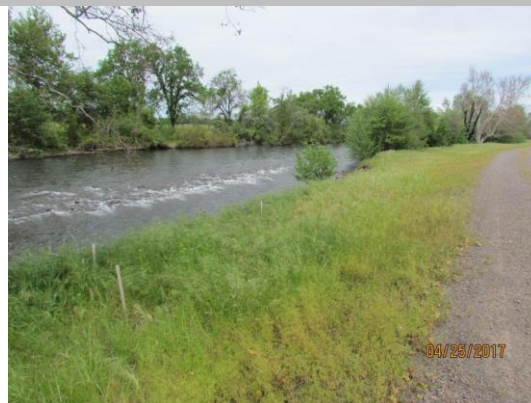
Photo 1 of 1 : SP_2018_NA0019_78_43_20180305_00017.jpg

LM Start	2.76	Rating **	A/W	Issue No.	43
LM End	2.78	Issue Type +	Ma	Location *	WS
Category	Earthen Levee			GPS Latitude/Longitude	
				Start	End
Item	Erosion / Bank Caving			39.964990 °	39.964763 °
				-122.028740 °	-122.029082 °
DWR ID	DWR_NA0019_01_s_2017_43				
Comment Code					
E2 : Schedule repair of erosion site prior to the next inspection.					
Inspector Comment					
Repair the erosion along the water side slope.

View of erosion along waterside toe.

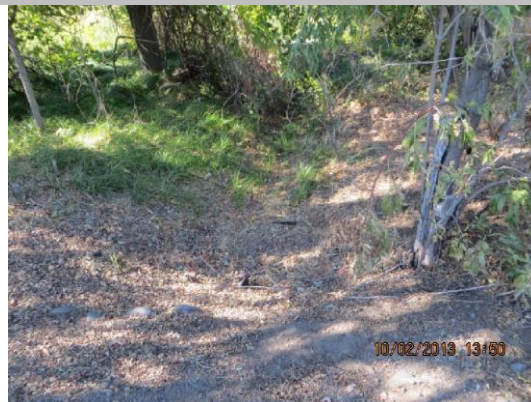
Photo 1 of 2 : UCIP_SP_2018_22824_38946.jpg

LM Start	2.86	Rating **	M	Issue No.	284
LM End	2.86	Issue Type +	Ma	Location *	
Category	Supplemental			GPS Latitude/Longitude	
				Start	End
Item	DWR UCIP LMA Responsibility			39.963938 °	39.963938 °
				-122.030128 °	-122.030128 °
DWR ID					
Comment Code					
Inspector Comment					
FS_ID:22824					
DS_ID:20767					
EP_NO: N/A					
Repair Type: Non-Urgent					
Crossing Status: Found					
UCIP Comments: Pipe blocked by soil.					
FIELD_STRUCT_DESC: 24-inch corrugated metal drainage pipe					
through the levee, 6 feet below the crown. Flap gate on the waterside					
(WS) end. [Additional Reference(s): DWR Levee Log, 1992. USACE					
Sacramento O&M Manual 509, March 1957, (Assumed Station 137+50)					
Drawing No. 50-4-2394].					
FS Date: 10/2/2013

Flapgate blocked by soil and debris.

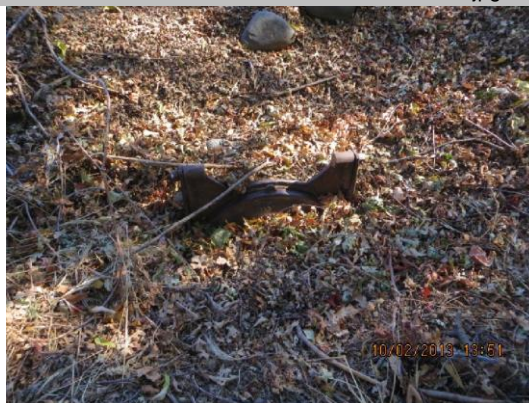
Photo 2 of 2 : UCIP_SP_2018_22824_38945.jpg

LM Start	2.86	Rating **	M	Issue No.	284 (cont)	
LM End	2.86	Issue Type +	Ma	Location *		
Category	Supplemental			GPS Latitude/Longitude		
				Start		End
Item	DWR UCIP LMA Responsibility			39.963938 °		39.963938 °
				-122.030128 °		-122.030128 °
DWR ID						
Comment Code						
Inspector Comment						
FS_ID:22824						
DS_ID:20767						
EP_NO: N/A						
Repair Type: Non-Urgent						
Crossing Status: Found						
UCIP Comments: Pipe blocked by soil.						
FIELD_STRUCT_DESC: 24-inch corrugated metal drainage pipe						
through the levee, 6 feet below the crown. Flap gate on the waterside						
(WS) end. [Additional Reference(s): DWR Levee Log, 1992. USACE						
Sacramento O&M Manual 509, March 1957, (Assumed Station 137+50)						
Drawing No. 50-4-2394].						
FS Date: 10/2/2013

Flapgate blocked by soil and debris.

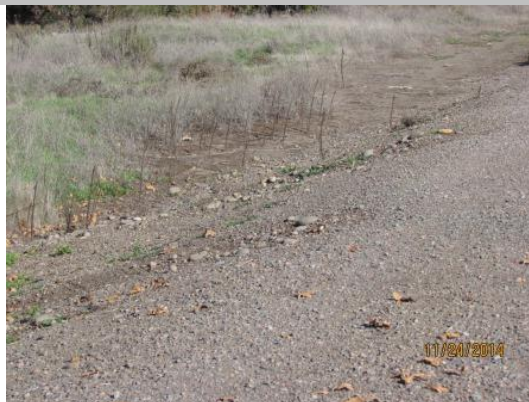
Photo 1 of 1 : SP_2018_NA0019_78_38_20180305_00013.jpg

LM Start	2.86	Rating **	M	Issue No.	38
LM End	2.86	Issue Type +	Ma	Location *	LS
Category	Earthen Levee			GPS Latitude/Longitude	
				Start	End
Item	Slope Stability			39.963928 °	39.963928 °
				-122.030120 °	-122.030120 °
DWR ID	DWR_NA0019_01_f_2014_38				
Comment Code					
S1 : Repair slope instability.					
Inspector Comment

View of erosion from the cattle on both slopes.

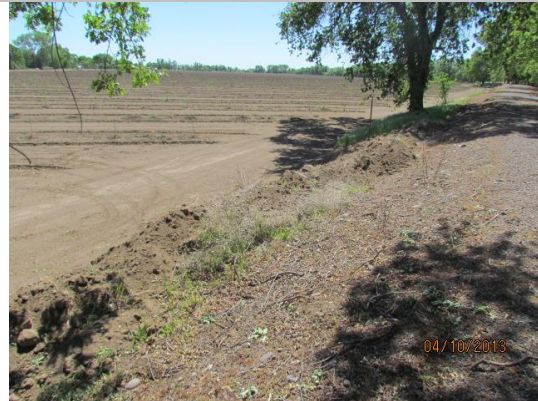
Photo 1 of 1 : SP_2018_NA0019_78_20_20180305_00008.jpg

LM Start	2.88	Rating **	M	Issue No.	20
LM End	2.88	Issue Type +	Ma	Location *	LS
Category	Earthen Levee			GPS Latitude/Longitude	
				Start	End
Item	Slope Stability			39.963709 °	39.963709 °
				-122.030384 °	-122.030384 °
DWR ID	DWR_NA0019_01_s _ 2013_20				
Comment Code					
S1 : Repair slope instability.					
Inspector Comment

View of the erosion along the landside slope.

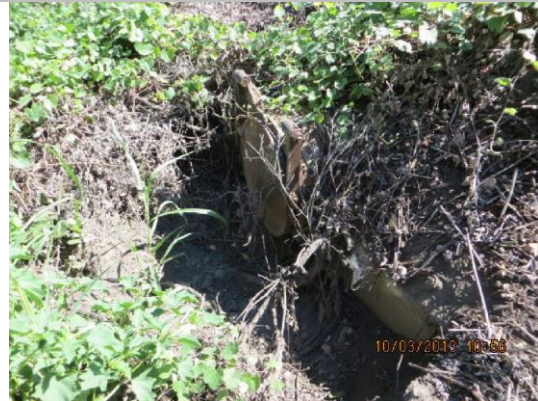
Photo 3 of 3 : UCIP_SP_2018_21741_36935.jpg

LM Start	4.03	Rating **	A/W	Issue No.	291 (cont)	
LM End	4.03	Issue Type +	Ma	Location *		
Category	Supplemental			GPS Latitude/Longitude		
				Start	End	
Item	DWR UCIP LMA Responsibility			39.941574 °	39.941574 °	
				-122.057597 °	-122.057597 °	
DWR ID						
Comment Code						
Inspector Comment						
FS_ID:21741						
DS_ID:20760						
EP_NO: N/A						
Repair Type: No Action Needed						
Crossing Status: Found						
UCIP Comments:						
FIELD_STRUCT_DESC: 24-inch corrugated metal drainage pipe						
through the levee, 5 feet below the crown. Flap gate on the waterside						
(WS) end. Headwalls on both sides of levee. [Additional Reference(s):						
DWR Levee Log, 1992. USACE Sacramento O&M Manual 509, March						
1957, (Assumed Station 5+00) Drawing No. 50-4-2394].						
FS Date: 10/3/2013

Flapgate and concrete headwall on WS toe.

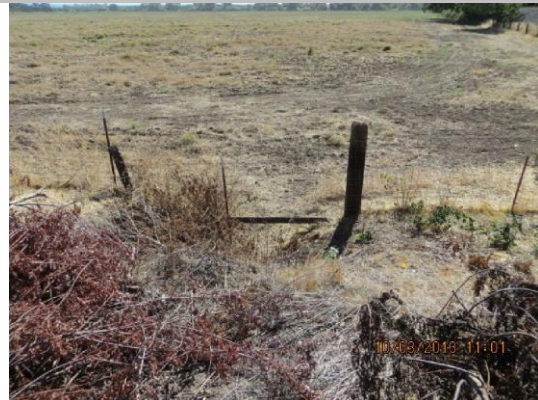
Photo 1 of 3 : UCIP_SP_2018_51441_36942.jpg

Comment Code						
Inspector Comment						
FS_ID:51441						
DS_ID:20762						
EP_NO: N/A						
Repair Type: Urgent						
Crossing Status: Found						
UCIP Comments: 12/05/2016 unable to complete inspection -- unable to locate. (O. Magana - DWR UCIP)10/03/2013 Gate missing from WS toe. (W. Wylie - DWR UCIP)						
FIELD_STRUCT_DESC: 24-inch corrugated metal drainage pipe through the levee, 5.5 feet below the crown. Flap gate located on the waterside (WS) end. Concrete headwall located on the landside (LS) toe. [Additional Reference(s): DWR Levee Log, 1992. USACE Sacramento O&M Manual Unit 509, March 1957, As-built drawing no. 50-4-2394 (Station 0+65)].						
FS Date: 12/5/2016

Inlet on LS toe.

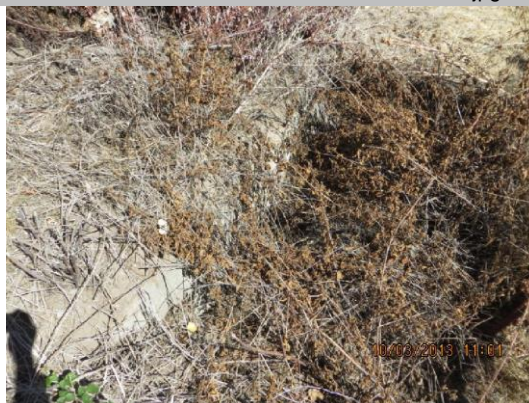
Photo 2 of 3 : UCIP_SP_2018_51441_36941.jpg

Comment Code						
Inspector Comment						
FS_ID:51441 DS_ID:20762 EP_NO: N/A Repair Type: Urgent Crossing Status: Found UCIP Comments: 12/05/2016 unable to complete inspection -- unable to locate. (O. Magana - DWR UCIP)10/03/2013 Gate missing from WS toe. (W. Wylie - DWR UCIP) FIELD_STRUCT_DESC: 24-inch corrugated metal drainage pipe through the levee, 5.5 feet below the crown. Flap gate located on the waterside (WS) end. Concrete headwall located on the landside (LS) toe. [Additional Reference(s): DWR Levee Log, 1992. USACE Sacramento O&M Manual Unit 509, March 1957, As-built drawing no. 50-4-2394 (Station 0+65)]. FS Date: 12/5/2016

Concrete headwall at inlet on LS toe.

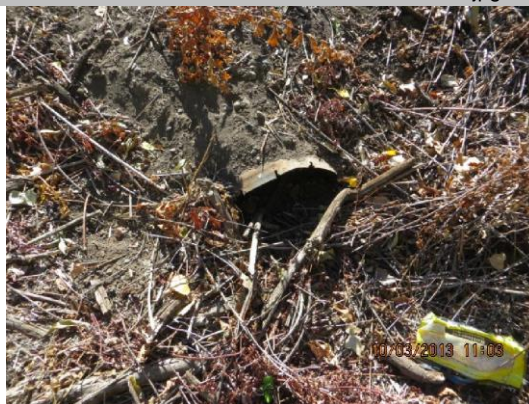
Photo 3 of 3 : UCIP_SP_2018_51441_36940.jpg

Flap gate missing from pipe at WS toe.

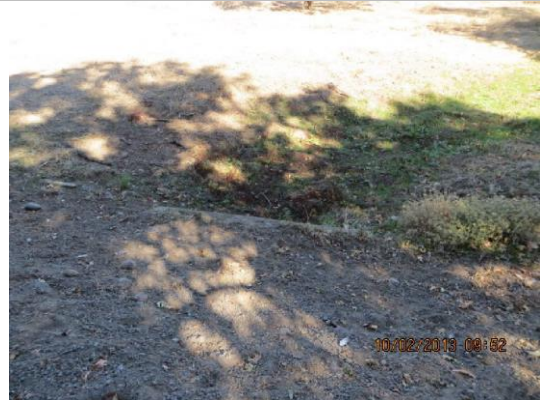
Photo 1 of 3 : UCIP_SP_2018_51442_36902.jpg

Comment Code						
Inspector Comment						
FS_ID:51442 DS_ID:20771 EP_NO: N/A Repair Type: Non-Urgent Crossing Status: Found UCIP Comments: 12/05/2016 Crossing has been downgraded from Urgent to Non-Urgent some debris blocking proper function of flapgate on WS. Recommend clearing debris from WS for flapgate to function properly. (O. Magana - DWR UCIP)10/01/2013 Debris blocking proper function of flapgate on WS toe. (W. Wylie - DWR UCIP) FIELD_STRUCT_DESC: 24-inch steel drainage pipe through the levee, 8.3 feet below the crown. Flap gate located on the waterside (WS) end. Concrete headwall located on the landside (LS). [Additional Reference(s): DWR Levee Log, 1992. USACE Sacramento O&M Manual Unit 509, March 1957, Unit 510, April 1963, Unit 511, May 1973, Unit 512, March 1964, Unit 513, December 1970, As-builts drawing 50-4-2394 (Station 155+40)]. FS Date: 12/5/2016

Concrete headwall at LS toe.

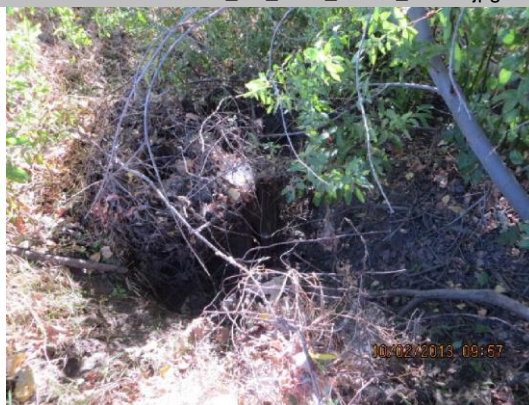
Photo 3 of 3 : UCIP_SP_2018_51442_36900.jpg

FS_ID:51442
DS_ID:20771
EP_NO: N/A
Repair Type: Non-Urgent
Crossing Status: Found
UCIP Comments: 12/05/2016 Crossing has been downgraded from Urgent to Non-Urgent some debris blocking proper function of flapgate on WS. Recommend clearing debris from WS for flapgate to function properly. (O. Magana - DWR UCIP)10/01/2013 Debris blocking proper function of flapgate on WS toe. (W. Wylie - DWR UCIP)
FIELD_STRUCT_DESC: 24-inch steel drainage pipe through the levee, 8.3 feet below the crown. Flap gate located on the waterside (WS) end. Concrete headwall located on the landside (LS). [Additional Reference(s): DWR Levee Log, 1992. USACE Sacramento O&M Manual Unit 509, March 1957, Unit 510, April 1963, Unit 511, May 1973, Unit 512, March 1964, Unit 513, December 1970, As-builts drawing 50-4-2394 (Station 155+40)].
FS Date: 12/5/2016

Outlet on WS toe.

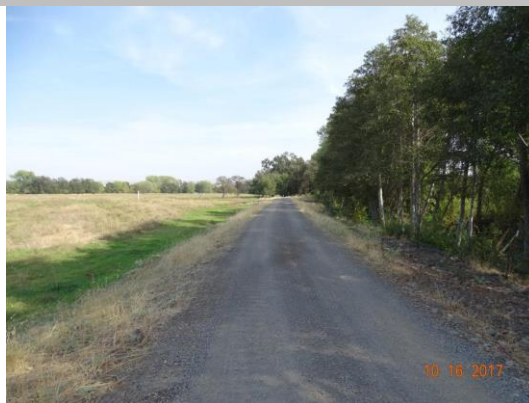
Photo 1 of 1 : SP_2018_NA0019_79_19_20180305_00011.jpg

View of the native grasses on both slopes.

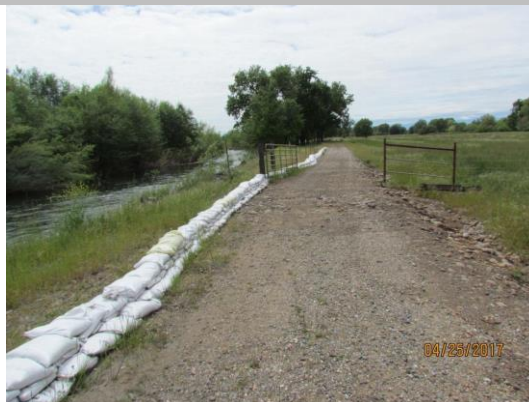
Photo 1 of 1 : SP_2018_NA0019_79_12_20180305_00007.jpg

LM Start	0.81	Rating **	M	Issue No.	12
LM End	0.85	Issue Type +	Ma	Location *	CR
Category	Earthen Levee			GPS Latitude/Longitude	
				Start	End
Item	Erosion / Bank Caving			39.968530 °	39.968248 °
				-122.023305 °	-122.023900 °
DWR ID	DWR_NA0019_02_s_2017_12				
Comment Code					
E2 : Schedule repair of erosion site prior to the next inspection.					
Inspector Comment					
Repair the crown roadway.

View of the erosion on the crown roadway.

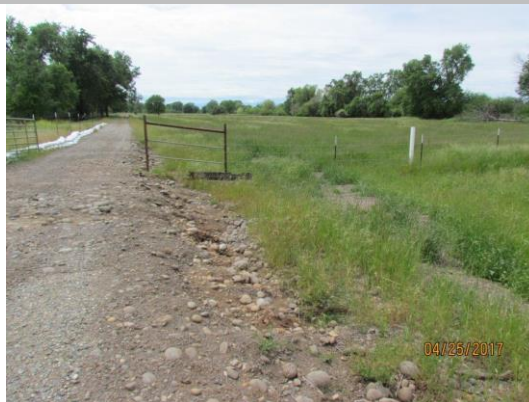
Photo 1 of 1 : SP_2018_NA0019_79_17_20180305_00010.jpg

LM Start	0.81	Rating **	M	Issue No.	17
LM End	0.85	Issue Type +	Ma	Location *	LS
Category	Earthen Levee			GPS Latitude/Longitude	
				Start	End
Item	Erosion / Bank Caving			39.968530 °	39.968248 °
				-122.023305 °	-122.023900 °
DWR ID	DWR_NA0019_02_s_2017_17				
Comment Code					
E2 : Schedule repair of erosion site prior to the next inspection.					
Inspector Comment					
Repair the erosion along the landside slope.

View of the erosion along the landside slope.

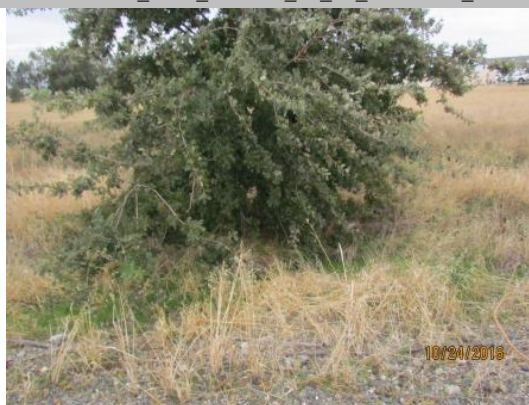
Photo 1 of 1 : SP_2018_NA0019_81_13_20180305_00008.jpg

View of a tree with overhanging branches.

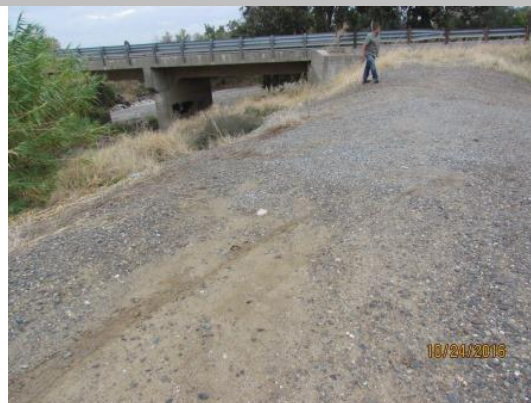
Photo 1 of 1 : SP_2018_NA0019_81_27_20180305_00016.jpg

View of the slope instability caused by vehicles.

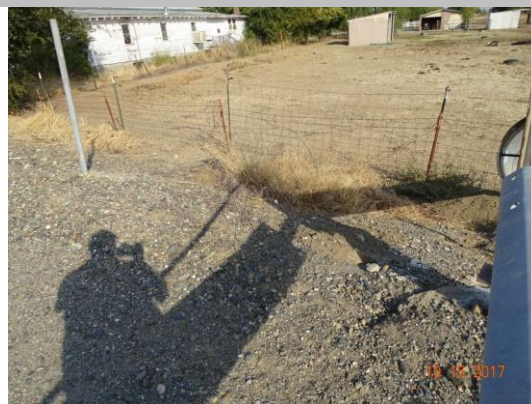
Photo 1 of 1 : SP_2018_NA0019_81_51_20180305_00024.jpg

View of the rodent holes along the landside slope.

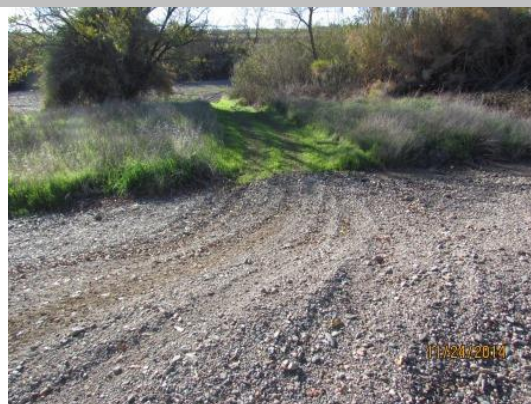
Photo 1 of 1 : SP_2018_NA0019_81_16_20180305_00011.jpg

View of the slope instability caused by vehicles along the waterside slope.

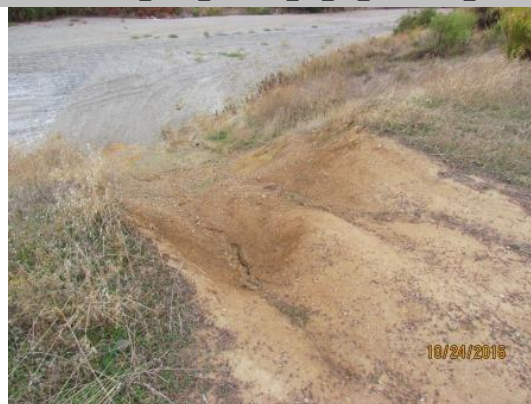
Photo 1 of 1 : SP_2018_NA0019_81_29_20180305_00017.jpg

View of the slope instability caused by vehicles along the waterside slope.

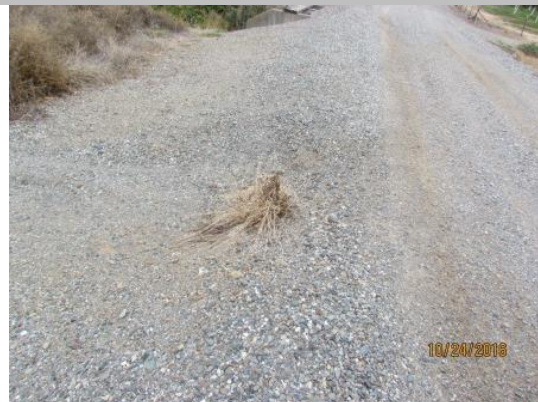
Photo 1 of 2 : SP_2018_NA0019_81_3_20180305_00003.jpg

View of a dip along the levee slope.

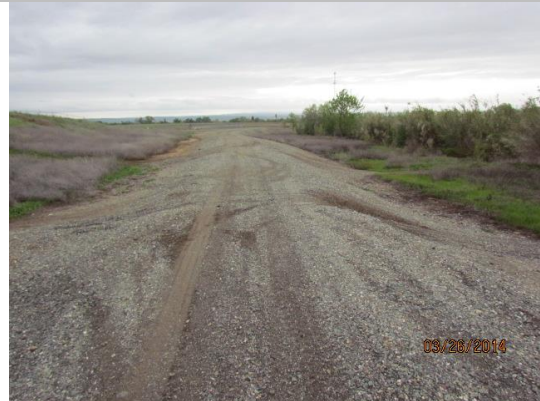
Photo 2 of 2 : SP_2018_NA0019_81_3_20180305_00004.jpg

View of the levee slope damaged by vehicle traffic.

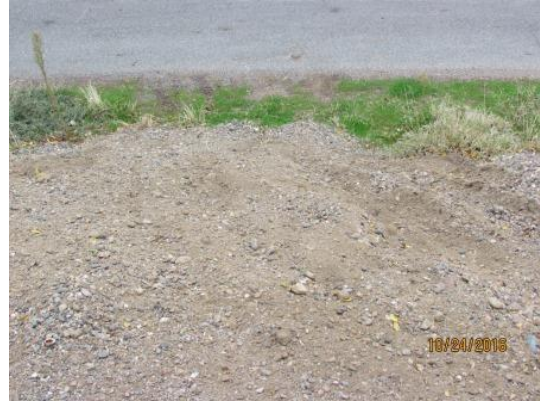
Photo 1 of 1 : SP_2018_NA0019_81_30_20180305_00018.jpg

View of the slope instability caused by vehicles along the landside slope.

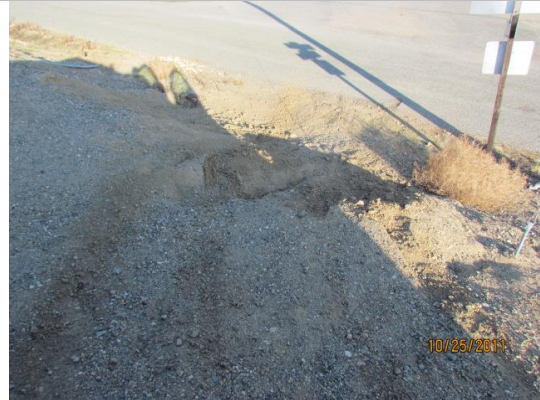
Photo 1 of 1 : SP_2018_NA0019_81_20_20180305_00013.jpg

View of the slope instability caused by vehicles along the landside slope.

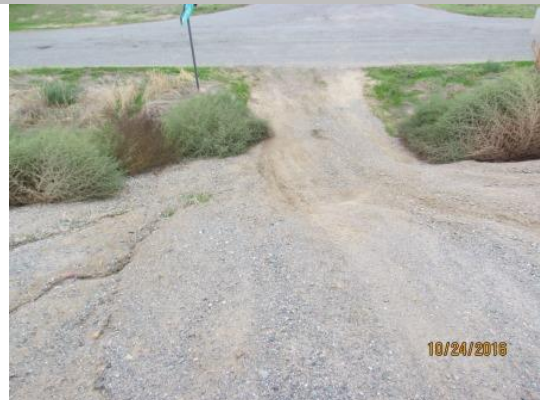
Photo 1 of 1 : SP_2018_NA0019_81_2_20180305_00002.jpg

View of the slope instability caused by vehicles along the landside slope.

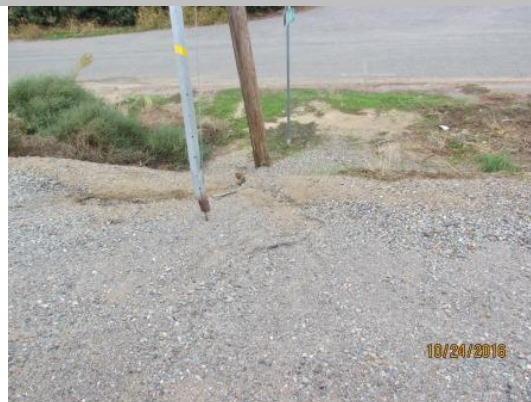
Photo 1 of 1 : SP_2018_NA0019_81_32_20180305_00020.jpg

View of the slope instability caused by vehicles along the landside slope.

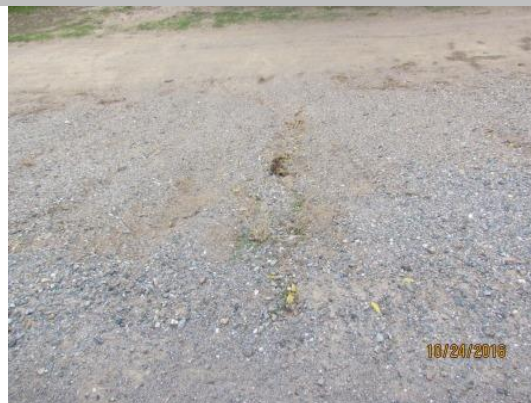
Photo 1 of 1 : SP_2018_NA0019_81_916_20180305_00025.jpg

View of the slope instability caused by vehicles along the waterside slope.

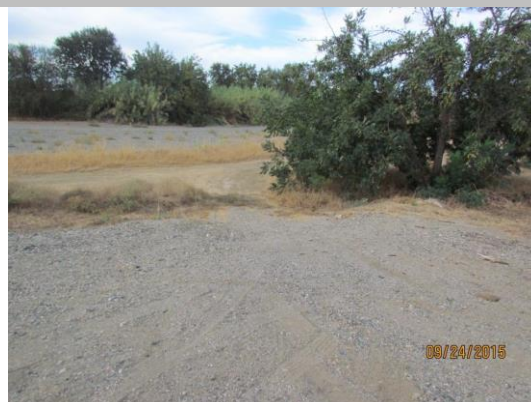
Photo 1 of 1 : SP_2018_NA0019_81_10_20180305_00006.jpg

View of the slope instability caused by vehicles along the landside slope.

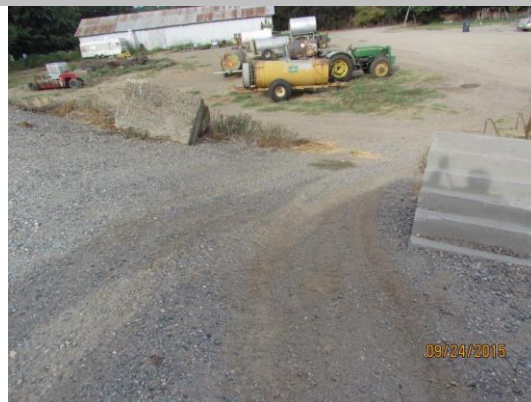
Photo 1 of 1 : SP_2018_NA0019_81_25_20180305_00015.jpg

View of the slope instability caused by vehicles along the landside slope.

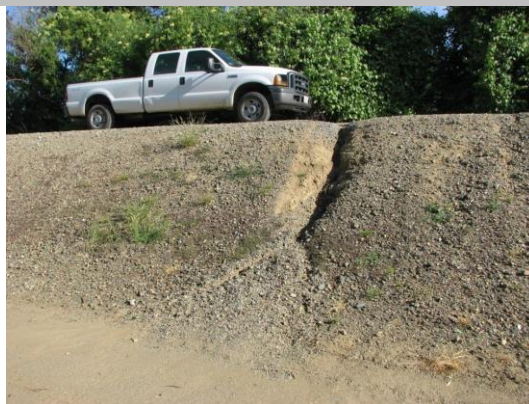
Photo 1 of 1 : SP_2018_NA0019_82_10_20180305_00004.jpg

View of the erosion along the landside slope.

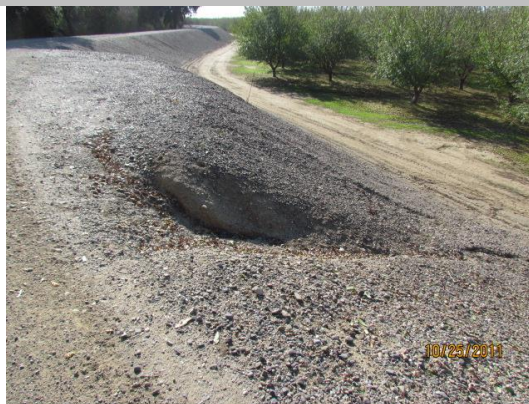
Photo 1 of 1 : SP_2018_NA0019_82_7_20180305_00002.jpg

View of the erosion along the landside slope.

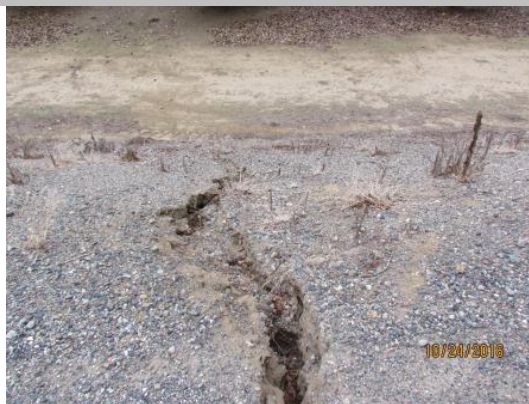
Photo 1 of 1 : SP_2018_NA0019_82_19_20180305_00008.jpg

View of the erosion along the landside slope.
